Inspection Report Minerals Regulatory Program Report Date: October 21, 2004

Mine Name: United Stone

Permit number: Unpermitted--
S/047/079

Inspection Date: October 18, 2004

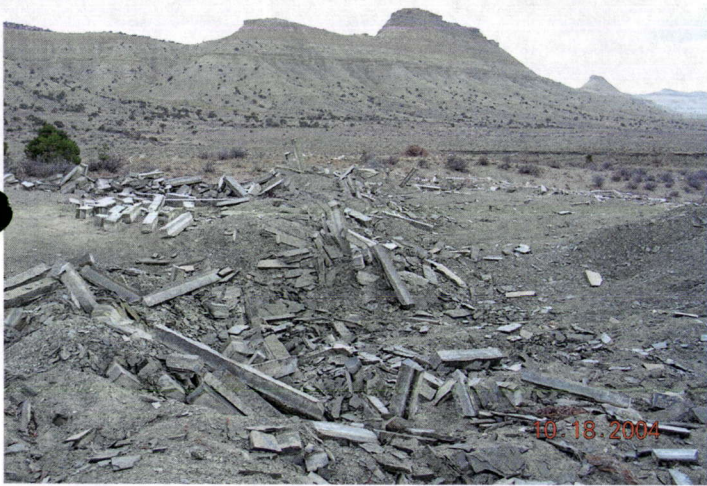
Photos 1 and 2 are of areas I found last July, and these have not changed. During this inspection, we found additional areas where the operator has been digging stone, and these are shown in Photos 3 and 4. The area in Photo 4 is the largest of the sites we saw.

Photo 1. Excavation and stone at one of the sites found in July.

I told the operator that reclamation could include taking some of the stone that has been dug, but there should be no more digging without first submitting a Notice of Intention and a reclamation bond. Reclamation should not be terribly complicated. Stone should be pushed so it does not protrude so obviously from the ground. Excavations should be filled in, but the final surface needs to be rough. By leaving a rough surface, more water will remain on site to increase plant germination and growth.

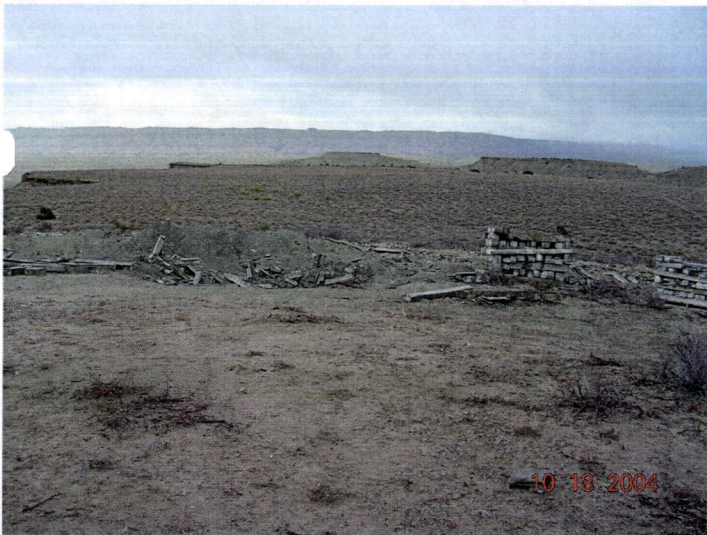
Photo 2. Another view of the area shown in Photo 1. Note the palletized stone.

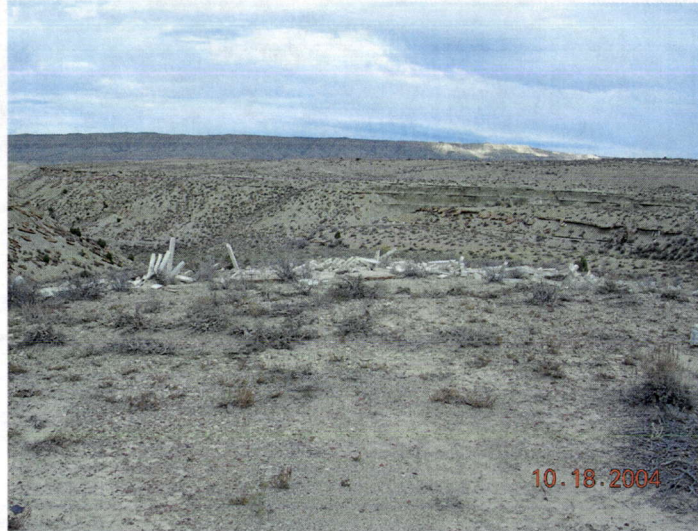
Photo 3. A site north and east of the disturbed areas shown in Photos 1 and 2.

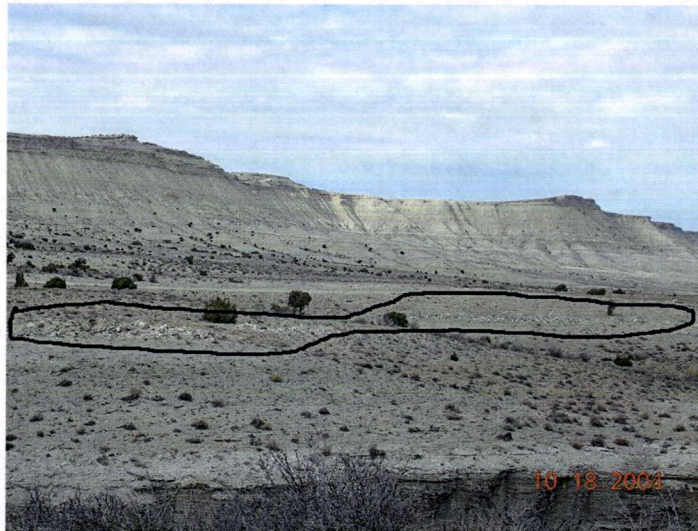
Photo 4. The marked area is a fairly extensive area of disturbance across the canyon from the area in Photo 3.
